### Federal Creosote Superfund Site OU2 Phase 1 Remedial Action Report

July 2005

## OU2 PHASE 1 REMEDIAL ACTION FEDERAL CREOSOTE SUPERFUND SITE MANVILLE, NEW JERSEY

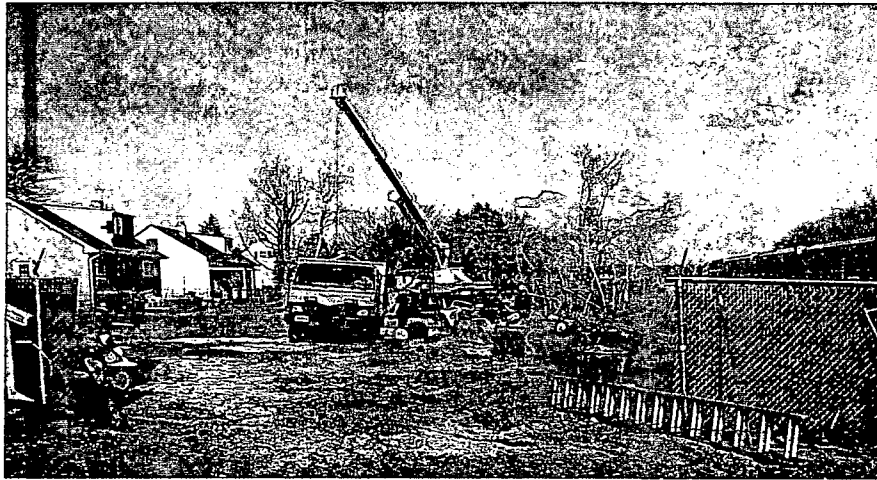
Photo 3-1 - Site Clearing

Trees, bushes, and ornamental plants, fences, etc. located within the excavation areas were removed prior to the beginning of the excavation activities. Waste generated during site clearing was disposed of at a municipal waste disposal facility as specified in the project documents.

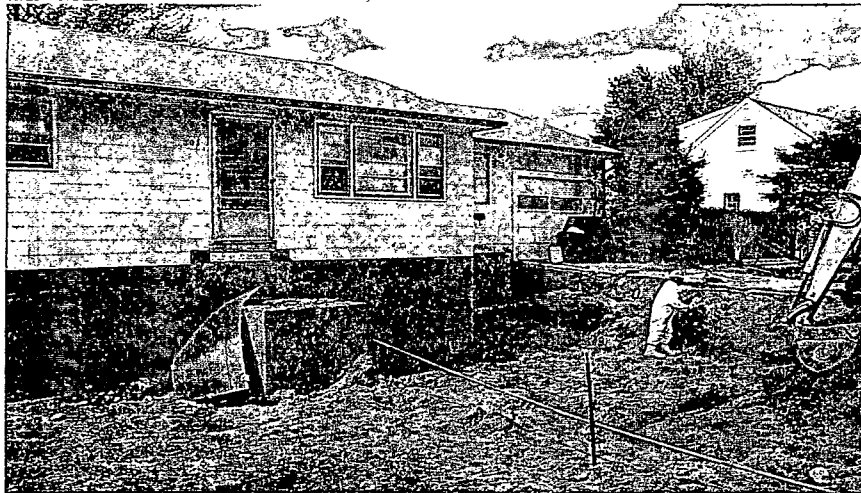
Photo 3-2 - Excavation adjacent to house

Dewatering system was not necessary during the OU2 Phase 1 remediation since the excavations were relatively shallow. Perched water encountered during the excavation as well as surface runoff that accumulated within the excavation areas was pumped to the on-site wastewater treatment plant for treatment prior to discharge.

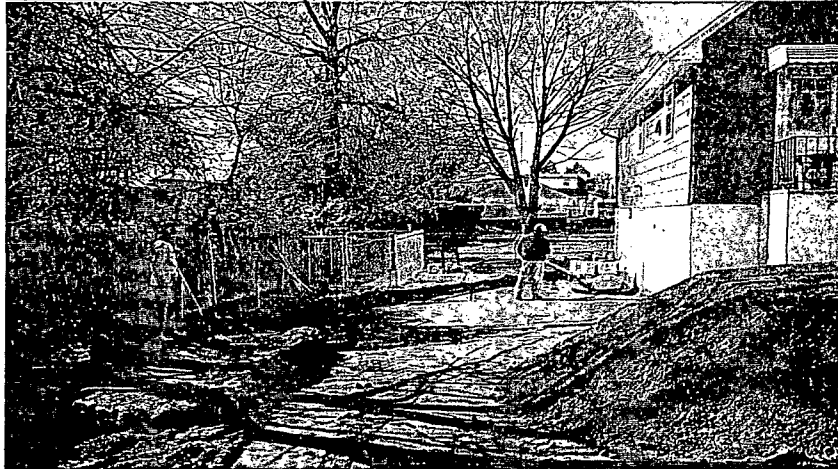
Photo 3-4 - Backfilling Operations

Backfill material was placed directly in the excavation and spread in horizontal layers up to 8 inches thick utilizing bulldozers. Placed material was compacted by utilizing an SD-40D roller to a minimum of 95% of its maximum dry density by Standard Proctor (ASTM D-698). Hand compactors and/or vibratory plates were utilized to compact areas immediately adjacent to houses or other structures. Compaction and moisture content testing of the backfill material was performed by SOR Testing Laboratories, Inc. located in Cedar Grove, New Jersey.

The upper layer of backfill material consisted of 6 inches of topsoil except in areas below sidewalk, walkway, driveway, etc. SES received the topsoil from EME Incorporated. The source of the material was a pit located in Plumstead Township, New Egypt, New Jersey.

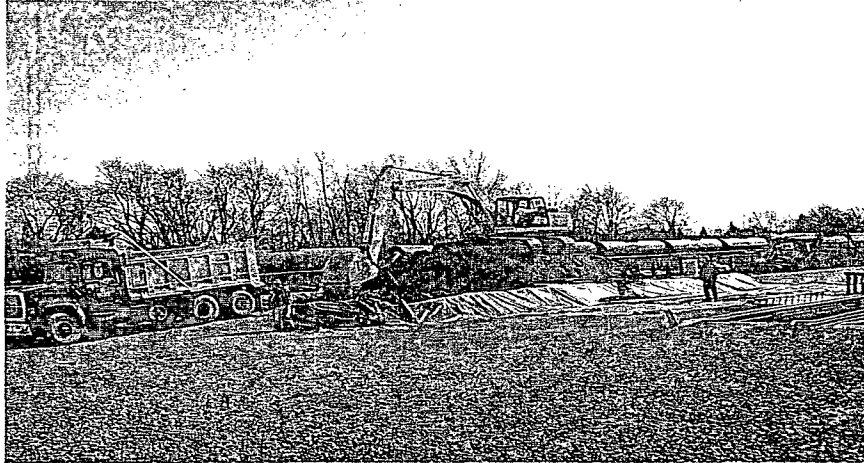
Photo 3-5 - Loading of excavated soil

Excavated materials were segregated into three stockpiles in accordance with the different waste types summarized in Table 3-1. Materials to be disposed of at Subtitle C and D facilities were transported to their respective facilities by utilizing 70,000-lb triaxle dump trucks. Materials requiring treatment were loaded into 80,000-lb dump trailers for transportation to the thermal treatment facility. Trucks transporting excavated materials to the facilities were required to be lined.

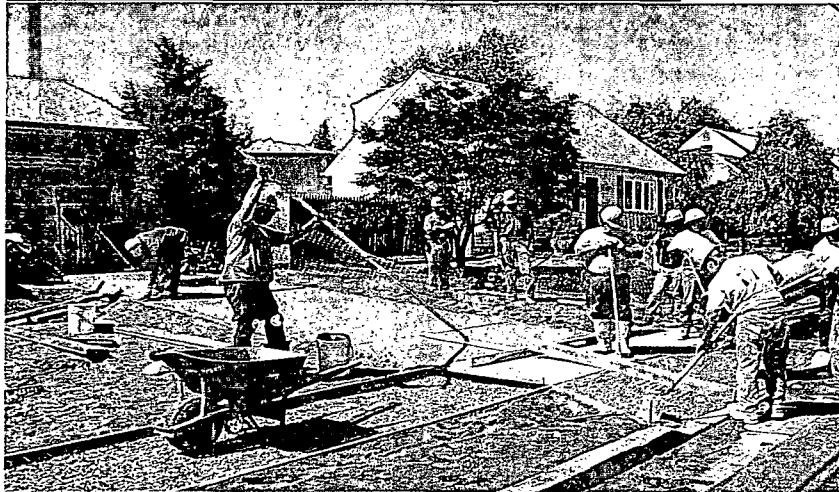
Photo 3-6 - Sidewalk and Driveway Restoration

Property features impacted by construction activities were restored and/or replaced in kind by the contractor. Roadways, curbs, sidewalks, etc. impacted by the remedial activities were also restored and/or rebuilt as shown on the restoration plans included in the contract drawings. Grass areas were restored with sod. Excavated areas were graded to closely follow the pre-excavation grades. Landscape items trees, shrubs, etc. removed during remedial activities were replaced as shown on the contract drawings. Utility service laterals impacted by the excavation were also restored. Utility work was performed by the respective utility companies or their authorized representatives, except for water, sanitary, and storm sewer work, which was performed by SES.
